**Flood Control Project Maintenance  
Levee Inspections**  
**LMA District Cover Sheet**  
**Spring 2020 Levee Inspection Results**

**Eastern Honcut Creek**

**Levee Inspection Report By Mile - Spring 2020**

Waterway	Bank	Unit Miles	Inspection Start/End	Inspector
Unit No. 01 Van Tress	Left	1.46	03/24/2020 03/24/2020	Sterling York

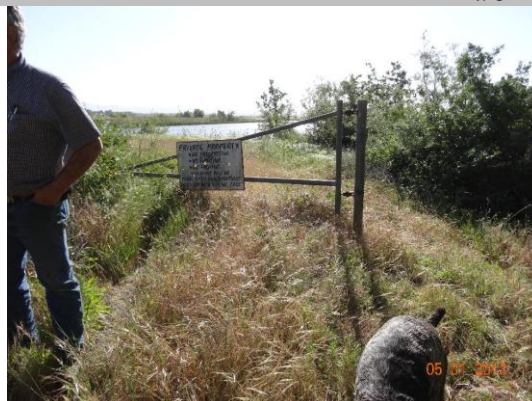
Photo 1 of 3 : UCIP\_SP\_2020\_52800\_24228.jpg

LM Start	0.01	Rating **	M	Issue No.	26	
LM End	0.01	Issue Type +	Ma	Location *		
Category	Supplemental			GPS Latitude/Longitude		
				Start		End
Item	DWR UCIP LMA Responsibility			39.298484 °		39.298484 °
				-121.569610 °		-121.569610 °
DWR ID	19167					
Comment Code						
Inspector Comment						
DS_ID:19167 FS_ID:52800 EP_NO: N/A Repair Type: Non-Urgent Crossing Status: Found UCIP Comments: 05/01/2013 Dense vegetation on landward side obstructs inspection. Vegetation needs to be cleared to perform utility crossing inspection. (DWR UCIP - O. Magana) FIELD_STRUCT_DESC: 24-inch corrugated metal drainage pipe through the levee, 12 feet below the crown. Flap gate located on the waterside (WS) end. [Additional Reference(s): DWR Levee Logs, 2005. USACE Sacramento O&M Manual Unit No. 151, November 1953, (Station 0+60)] FS Date: 5/1/2013

View of crown looking east.

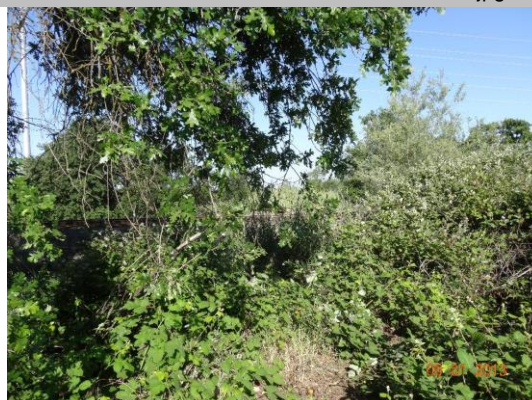
Photo 2 of 3 : UCIP\_SP\_2020\_52800\_24225.jpg

View of railroad looking west of crossing.

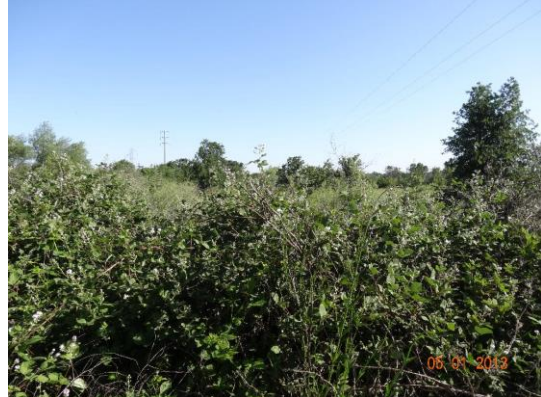
Photo 3 of 3 : UCIP\_SP\_2020\_52800\_24229.jpg

Dense vegetation on waterward side obstructing inspection.

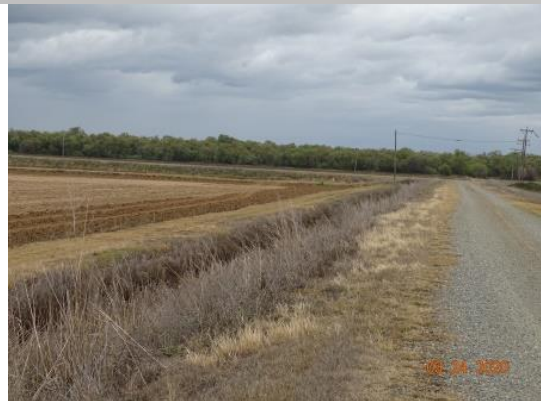
Photo 1 of 1 : SP\_2020\_NA0006\_252\_11\_20200401\_00027.jpg

LM Start	0.02	Rating **	M	Issue No.	11
LM End	1.44	Issue Type +	Ma	Location *	LS
Category	Earthen Levee			GPS Latitude/Longitude	
				Start	End
Item	Vegetation			39.298495 °	39.295257 °
				-121.569508 °	-121.546742 °
DWR ID	DWR_NA0006_01_f_2019_11				
Comment Code					
V1 : Control annual grass and weeds on the levee slopes and easements.					
Inspector Comment					
The annual vegetation on the landside has not been maintained this season, Spring 2020.

View looking downstream landside at the unmaintained annual vegetation, Spring 2020.

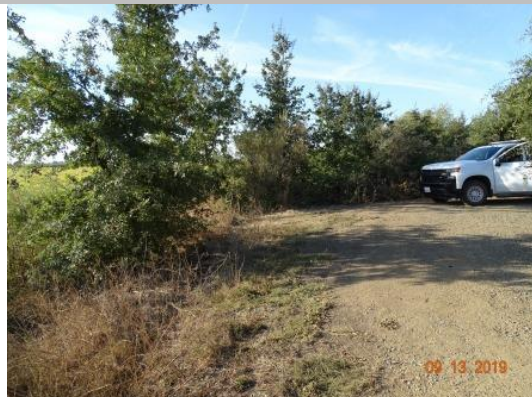
Photo 1 of 1 : SP\_2020\_NA0006\_252\_13\_20200227\_00004.jpg

LM Start	0.02	Rating **	U	Issue No.	13
LM End	0.02	Issue Type +	Ma	Location *	LS
Category	Earthen Levee			GPS Latitude/Longitude	
				Start	End
Item	Trim / Thin Trees			39.298493 °	39.298493 °
				-121.569506 °	-121.569506 °
DWR ID	DWR_NA0006_01_f_2019_13				
Comment Code					
T2 : Thin trees to allow visibility of the ground and room to flood fight.					
Inspector Comment					
There are trees that need the limbs trimmed up 5' for visibility and access on the landside, Spring 2020.

View looking downstream of trees that need the limbs trimmed up 5' for visibility and access on the landside.

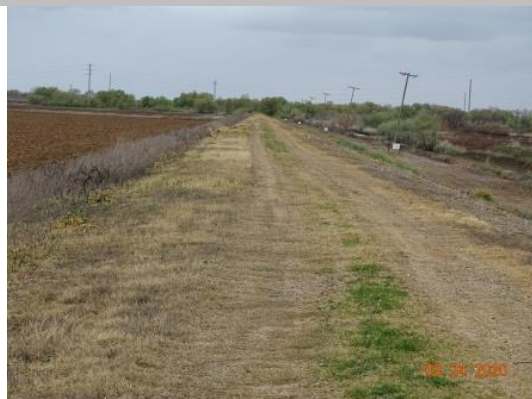
Photo 1 of 1 : SP\_2020\_NA0006\_252\_21\_20200401\_00028.jpg

LM Start	0.02	Rating **	U	Issue No.	21
LM End	0.66	Issue Type +	Ma	Location *	CR
Category	Earthen Levee			GPS Latitude/Longitude	
				Start	End
Item	Crown Surface / Depressions / Rutting			39.298504 °	39.297595 °
				-121.569502 °	-121.558310 °
DWR ID	DWR_NA0006_01_s_2015_21				
Comment Code					
C3 : Add appropriate gravel or road base. Grade and compact.					
Inspector Comment					
Place appropriate gravel on the crown roadway to make it an all weather road, Spring 2020.

View of the crown looking downstream at a section of road that needs all weather surface, Spring 2020.

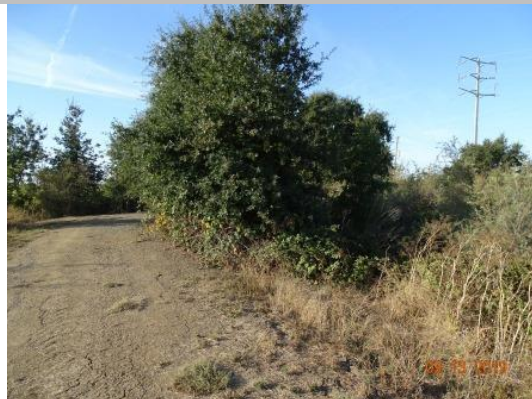
Photo 1 of 1 : SP\_2020\_NA0006\_252\_20\_20200227\_00007.jpg

LM Start	0.02	Rating **	U	Issue No.	20
LM End	0.02	Issue Type +	Ma	Location *	WS
Category	Earthen Levee			GPS Latitude/Longitude	
				Start	End
Item	Trim / Thin Trees			39.298563 °	39.298563 °
				-121.569432 °	-121.569432 °
DWR ID	DWR_NA0006_01_f_2016_20				
Comment Code					
T1 : Trim trees to at least five feet above ground level.					
Inspector Comment					
There is a tree that needs the limbs trimmed up 5' for visibility and access on the waterside, Spring 2020.

View of a tree that needs the limbs trimmed up 5' for visibility and access on the waterside looking downstream.

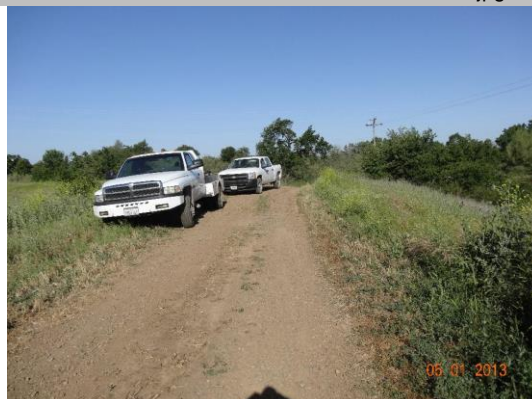
Photo 1 of 3 : UCIP\_SP\_2020\_52801\_24241.jpg

LM Start	0.09	Rating **	M	Issue No.	27	
LM End	0.09	Issue Type +	Ma	Location *		
Category	Supplemental			GPS Latitude/Longitude		
				Start		End
Item	DWR UCIP LMA Responsibility			39.299106 °	39.299106 °	
				-121.568749 °	-121.568749 °	
DWR ID	19168					
Comment Code						
Inspector Comment						
DS_ID:19168 FS_ID:52801 EP_NO: N/A Repair Type: Non-Urgent Crossing Status: Found UCIP Comments: 05/01/2013 Dense vegetation on waterward side and landward side obstructs inspection. Need to clear vegetation on slopes to conduct proper crossing evaluation. (DWR UCIP - O. Magana) FIELD_STRUCT_DESC: 24-inch corrugated metal drainage pipe through the levee, 10 feet below the crown. Flap gate located on the waterside (WS) end. [Additional Reference(s): DWR Levee Logs, 2005. USACE Sacramento O&M Manual Unit No. 151, November 1953, (Station 5+65)] FS Date: 5/1/2013

Overview of levee crown at crossing looking upstream.

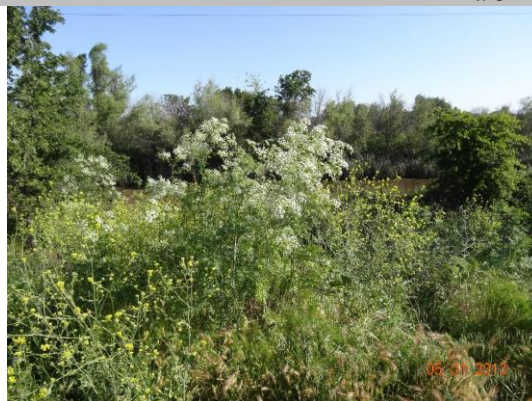
Photo 2 of 3 : UCIP\_SP\_2020\_52801\_24236.jpg

Dense vegetation obstructing waterward slope.

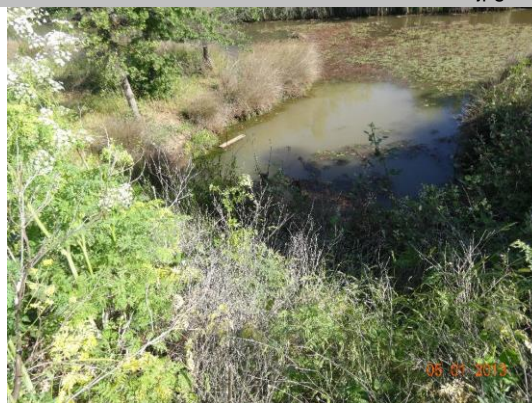
Photo 3 of 3 : UCIP\_SP\_2020\_52801\_24238.jpg

Overview of waterward side (outlet).

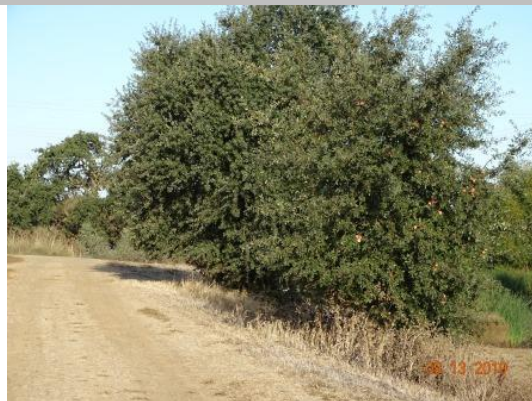
Photo 1 of 1 : SP\_2020\_NA0006\_252\_22\_20200227\_00009.jpg

LM Start	0.10	Rating **	M	Issue No.	22
LM End	0.10	Issue Type +	Ma	Location *	WS
Category	Earthen Levee			GPS Latitude/Longitude	
				Start	End
Item	Trim / Thin Trees			39.299078 °	39.299078 °
				-121.568633 °	-121.568633 °
DWR ID	DWR_NA0006_01_f_2016_22				
Comment Code					
T1 : Trim trees to at least five feet above ground level.					
Inspector Comment					
There is a tree that needs the limbs trimmed up 5' for visibility and access on the waterside. Spring 2020.

View looking downstream waterside of a tree that needs the limbs trimmed up 5' for visibility and access.

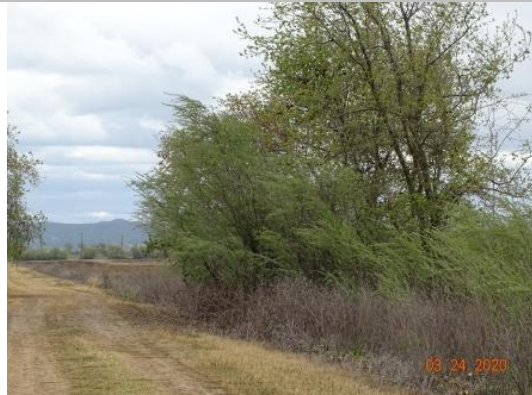
Photo 1 of 1 : SP\_2020\_NA0006\_252\_23\_20200401\_00029.jpg

LM Start	0.21	Rating **	U	Issue No.	23
LM End	0.21	Issue Type +	Ma	Location *	LS
Category	Earthen Levee			GPS Latitude/Longitude	
				Start	End
Item	Trim / Thin Trees			39.298816 °	39.298816 °
				-121.566529 °	-121.566529 °
DWR ID	DWR_NA0006_01_f_2016_23				
Comment Code					
T3 : Trim and thin trees to allow visibility of the ground and room to flood fight.					
Inspector Comment					
There are trees that need the limbs trimmed up 5' for visibility and access on the landside, Spring 2020.

View looking upstream landside of trees that need the limbs trimmed up 5' for visibility and access on the landside, Spring 2020.

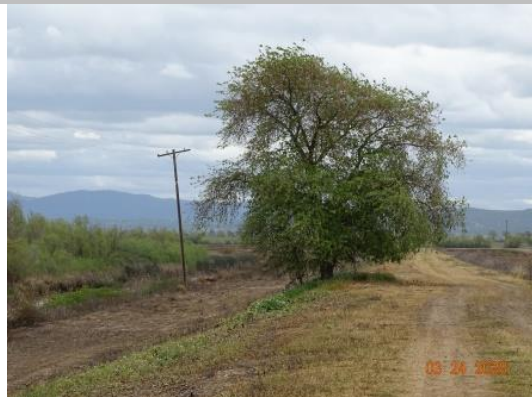
Photo 1 of 1 : SP\_2020\_NA0006\_252\_25\_20200401\_00030.jpg

LM Start	0.23	Rating **	M	Issue No.	25
LM End	0.23	Issue Type +	Ma	Location *	WS
Category	Earthen Levee			GPS Latitude/Longitude	
				Start	End
Item	Trim / Thin Trees			39.298776 °	39.298776 °
				-121.566158 °	-121.566158 °
DWR ID	DWR_NA0006_01_f_2016_25				
Comment Code					
T1 : Trim trees to at least five feet above ground level.					
Inspector Comment					
There is a tree that needs the limbs trimmed up 5' for visibility and access on the waterside, Spring 2020.

View looking upstream waterside of a tree that needs the limbs trimmed up 5' for visibility and access on the waterside, Spring 2020.

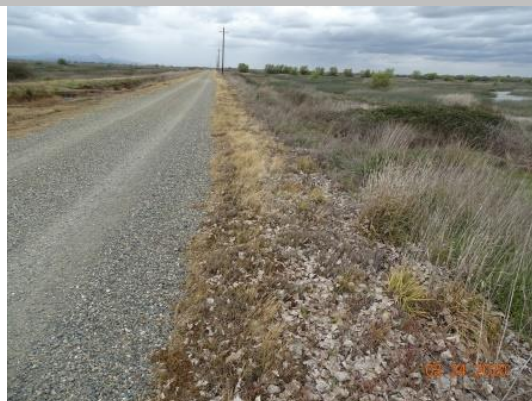
Photo 1 of 1 : SP\_2020\_NA0006\_252\_12\_20200401\_00031.jpg

LM Start	0.66	Rating **	M	Issue No.	12
LM End	0.85	Issue Type +	Ma	Location *	WS
Category	Earthen Levee			GPS Latitude/Longitude	
				Start	End
Item	Vegetation			39.297589 °	39.294995 °
				-121.558342 °	-121.557823 °
DWR ID	DWR_NA0006_01_f_ 2019_12				
Comment Code					
V1 : Control annual grass and weeds on the levee slopes and easements.					
Inspector Comment					
The annual vegetation on the waterside in this section has not been maintained this season, Spring 2020.

View looking downstream waterside at the section of unmaintained annual vegetation, Spring 2020.

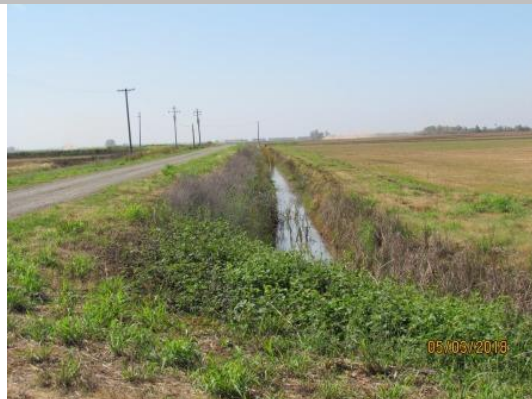
Photo 1 of 1 : SP\_2020\_NA0006\_252\_15\_20200227\_00005.jpg

LM Start	0.68	Rating **	M	Issue No.	15
LM End	1.45	Issue Type +	En	Location *	LS
Category	Earthen Levee			GPS Latitude/Longitude	
				Start	End
Item	Encroachments			39.297426 °	39.295260 °
				-121.558319 °	-121.546719 °
DWR ID	DWR_NA0006_01_s_2018_15				
Comment Code					
DT : Ditch					
Inspector Comment					
There is a ditch on the landside of the levee.

View looking upstream of landside ditch at levee toe.

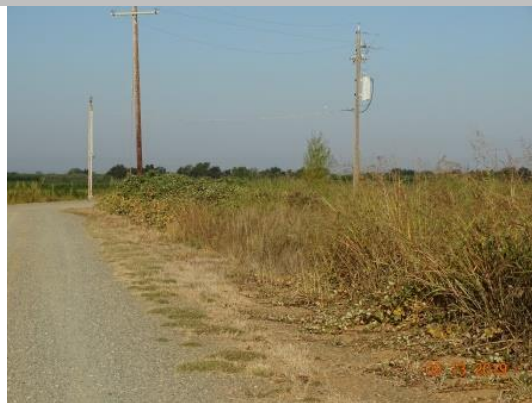
Photo 1 of 1 : SP\_2020\_NA0006\_252\_1\_20200227\_00001.jpg

LM Start	0.85	Rating **	U	Issue No.	1
LM End	0.96	Issue Type +	Ma	Location *	WS
Category	Earthen Levee			GPS Latitude/Longitude	
				Start	End
Item	Vegetation			39.294995 °	39.295021 °
				-121.557823 °	-121.555813 °
DWR ID	DWR_NA0006_01_f_2016_1				
Comment Code					
V2 : Remove the wild growth other than native grasses from the levee slopes.					
Inspector Comment					
Remove blackberry bushes that are taking over the waterside slope, Spring 2020.

View of blackberry bushes that are covering the waterside slope. Looking downstream waterside.

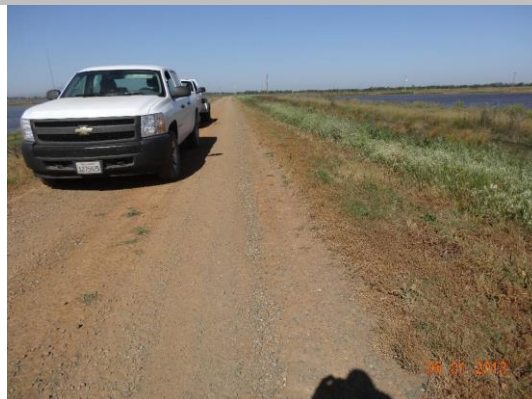
Photo 1 of 3 : UCIP\_SP\_2020\_52802\_24253.jpg

Comment Code						
Inspector Comment						
DS_ID:19172 FS_ID:52802 EP_NO: 9610 Repair Type: Non-Urgent Crossing Status: Found UCIP Comments: 05/01/2013 Scouring occuring directly across pipe on access road. Need to determine permit authorizing updates to crossing. Crossing appears to be no more than 10 years old. (DWR UCIP - O. Magana) FIELD_STRUCT_DESC: 1 of 2: 24-inch corrugated metal irrigation pipe through the levee, 6 feet below the crown. Slide gates are installed on waterside (WS) end of pipe. (two 24-inch pipe authorized Permit No. 9610, 1974-Honcut Creek Ranch). [Additional Reference(s): DWR Levee Logs, 2005. USACE Sacramento O&M Manual Unit No. 151, November 1953, (Station 53+70)] FS Date: 5/1/2013

Overview of levee crown looking upstream at crossing.

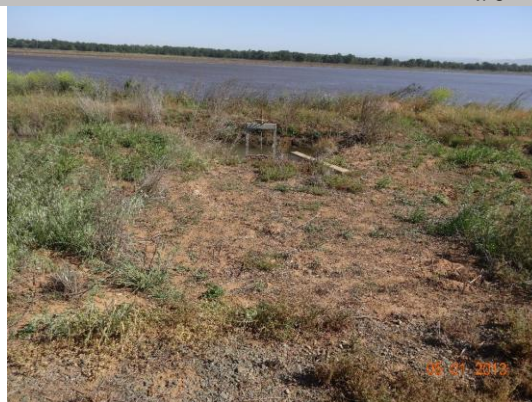
Photo 2 of 3 : UCIP\_SP\_2020\_52802\_24252.jpg

View of waterward side.

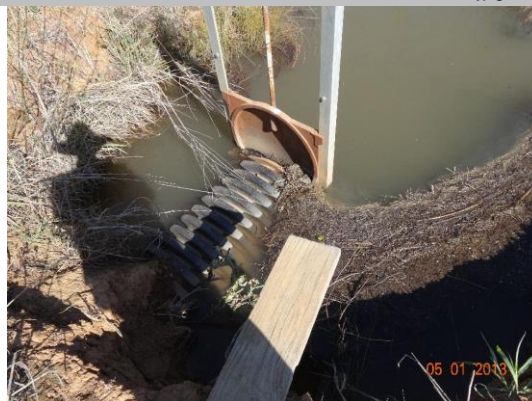
Photo 3 of 3 : UCIP\_SP\_2020\_52802\_24251.jpg

Positive closure device on waterward side.

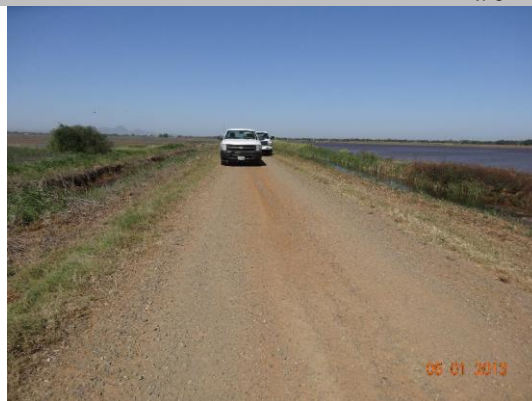
Photo 1 of 3 : UCIP\_SP\_2020\_52803\_24259.jpg

DS\_ID:19174  
 FS\_ID:52803  
 EP\_NO: N/A  
 Repair Type: Non-Urgent  
 Crossing Status: Found  
 UCIP Comments: 05/01/2013 Recent repair will need to contact owner to follow-up. (DWR UCIP - O. Magana)  
 FIELD\_STRUCT\_DESC: 24-inch corrugated metal drainage pipe through the levee, 10 feet below the crown. Flap gate located on the waterside (WS).  
 FS Date: 5/1/2013

Overview of levee crown looking upstream from crossing.

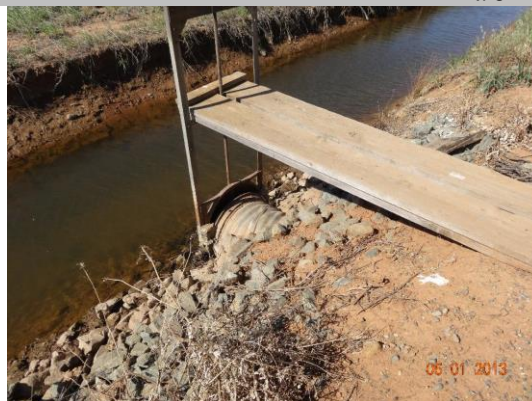
Photo 2 of 3 : UCIP\_SP\_2020\_52803\_24258.jpg

View of landward side: positive closure device, walkway, and rip rap on slope.

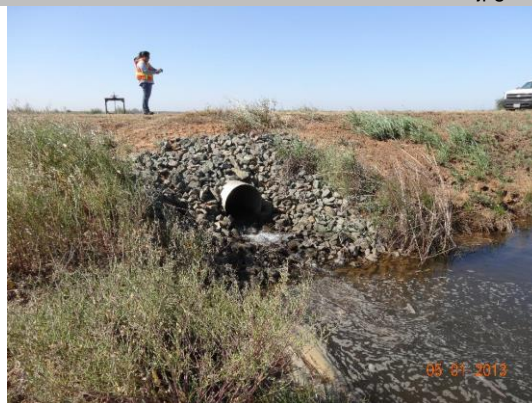
Photo 3 of 3 : UCIP\_SP\_2020\_52803\_24257.jpg

View of waterward side crossing looks fairly new.

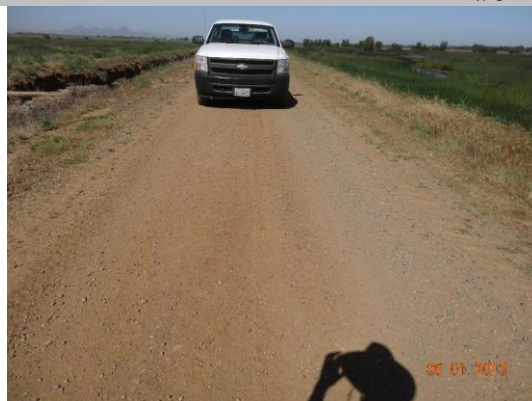
Photo 1 of 3 : UCIP\_SP\_2020\_52804\_24275.jpg

LM Start	1.44	Rating **	M	Issue No.	30	
LM End	1.44	Issue Type +	En	Location *		
Category	Supplemental			GPS Latitude/Longitude		
				Start	End	
Item	DWR UCIP Field Study			39.295238 °	39.295238 °	
				-121.546755 °	-121.546755 °	
DWR ID	19169					
Comment Code						
Inspector Comment						
DS_ID:19169 FS_ID:52804 EP_NO: N/A Repair Type: Non-Urgent Crossing Status: Found UCIP Comments: 05/01/2013 Need to determine permit authorizing work. (DWR UCIP - O. Magana) FIELD_STRUCT_DESC: 18-inch corrugated metal irrigation pipe through the levee, 8 feet below the crown. Slide gate located on the landside (LS) end. Rock revetment on the LS near slide-gate. [Additional Reference(s): DWR Levee Logs, 2005] FS Date: 5/1/2013

View of levee crown looking upstream at crossing.

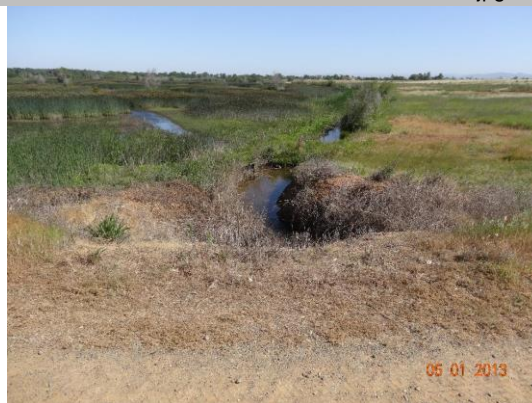
Photo 2 of 3 : UCIP\_SP\_2020\_52804\_24272.jpg

View of waterward side.

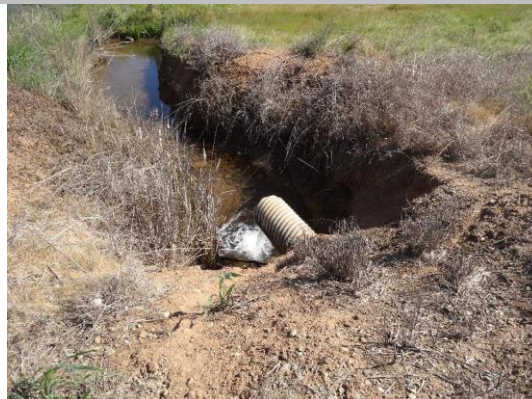
Photo 3 of 3 : UCIP\_SP\_2020\_52804\_24274.jpg

Crossing visible on waterward side.
